Home Buyer Drainage Survey Plus Report Prepared For:

Property Address

Drainage Survey Plus Home Buyer

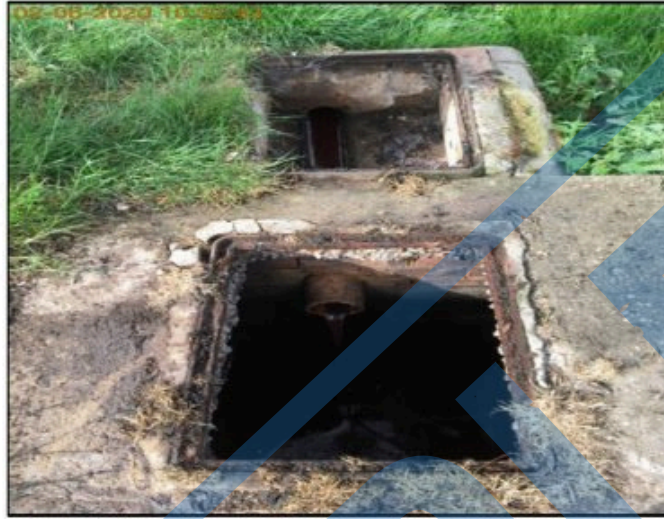
Photograph(s) of tank after the system was emptied:

Construction / design of the tank at the property: A rectangle brick constructed tank with rendered internal surfaces

Dimensions of the tank:	Length - 1.8m Depth (to inlet) - 1.3m Width - 1.5m
	All internal measurements.
Depth (below ground level) of the inlet pipe into the tank:	0.4m
Depth (below ground level) of the outlet pipe from the tank (if applicable):	0.4m
Capacity of the tank (below the inlet pipe):	3,510 litres
Based on our calculations, is the tank adequately sized for the maximum potential occupancy of the property?	Yes
Is there a manhole chamber upstream of the tank?	Yes
Depth below ground level of the next upstream manhole chamber from the tank:	0.35m
Overall condition of the tank:	Good
On arrival was the effluent level within the tank at the expected operating level?	Yes
Was there any damage observed to the tank during the inspection?	No
When the tank was emptied, was there any water observed returning to the tank from the outlet?	No
Was the outlet pipework accessible from the tank in order to conduct a CCTV survey?	Yes

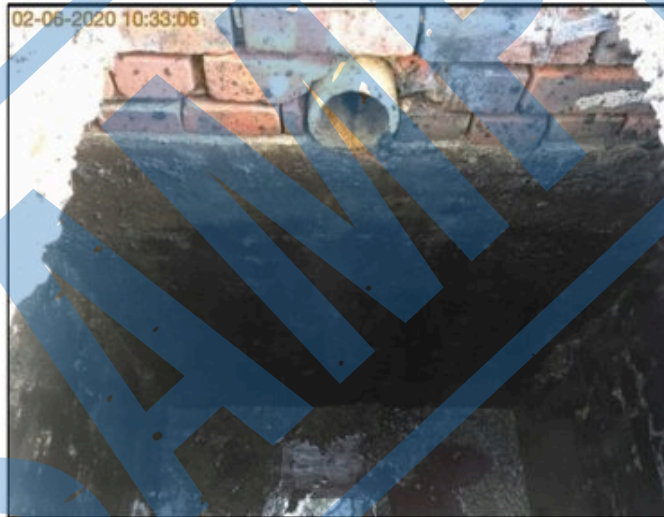
Tank empty photograph 2:

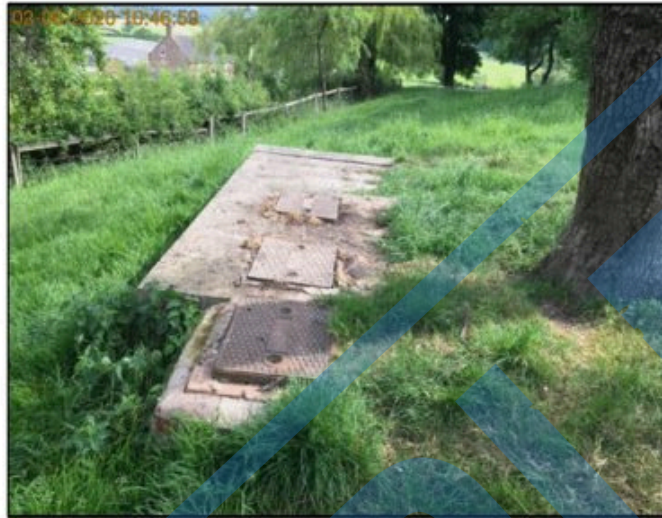
Photograph of the general area of the tank:

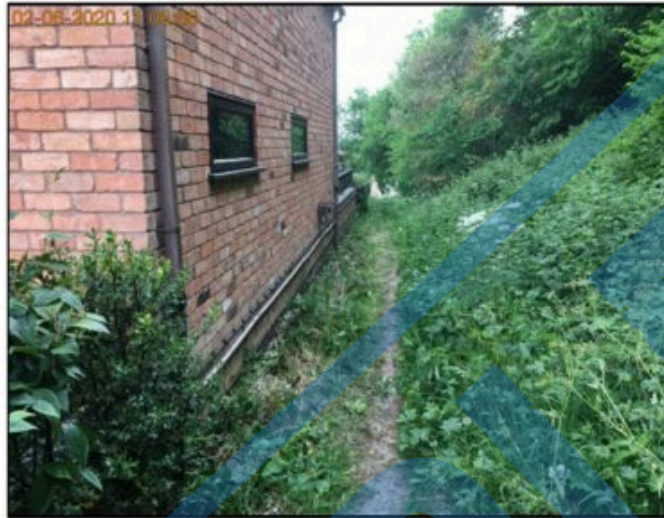
2 x cross connection to the garage and office,

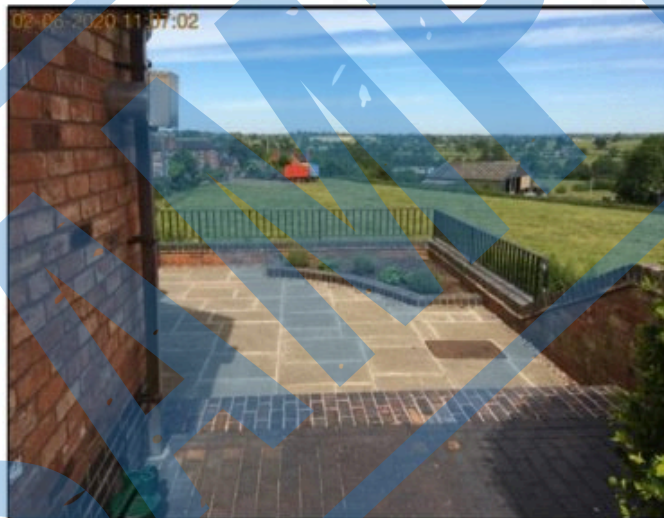
Cross connection at rear.

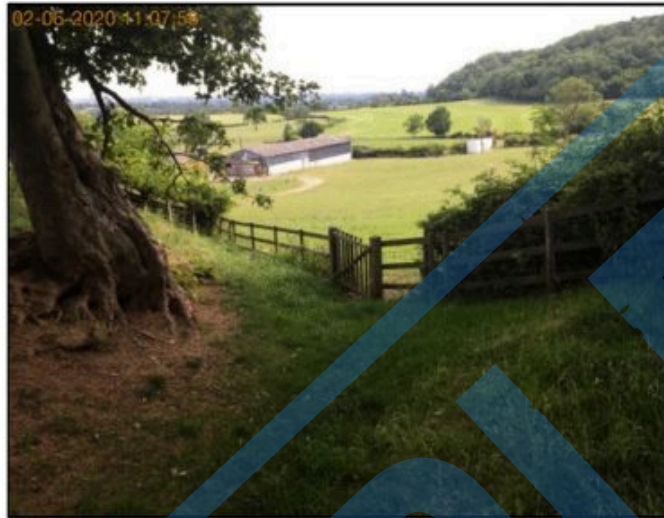
Rear boundary.

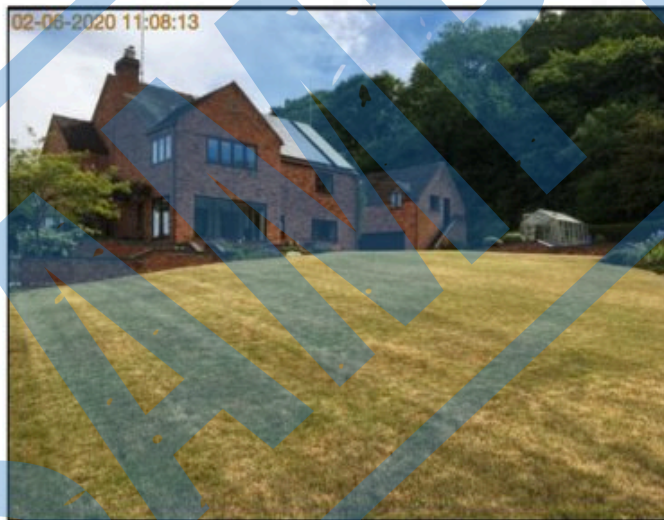
Rear garden.

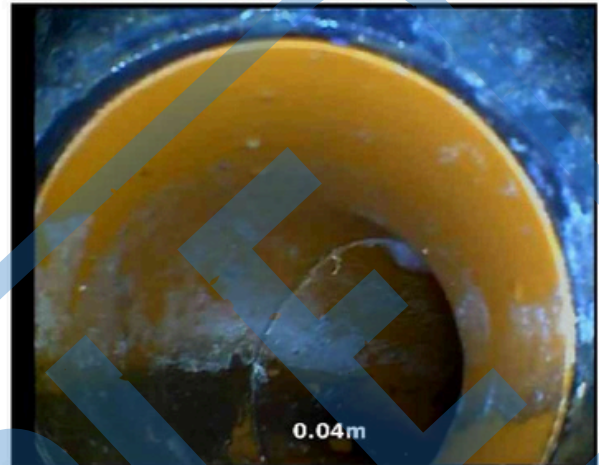
0.04m

MH1X_b8dcafa-5f8a-4f10-9bec-bf7dca9b7672_20250120_133350_587.jpg, 00:00:01, 0.04 m
 Line of sewer deviates right

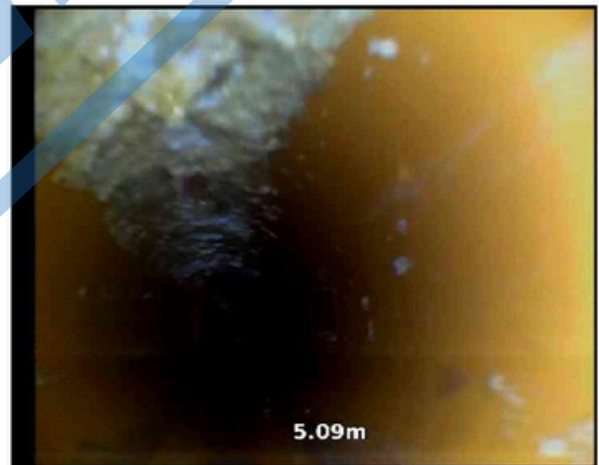
5.09m

MH1X_c3427ae5-0be0-45a8-a0ab-e60ed2c62379_20250120_133507_718.jpg, 00:00:28, 5.09 m
 Debris, grease from 11 o'clock to 1 o'clock, 5% cross-sectional area loss, change

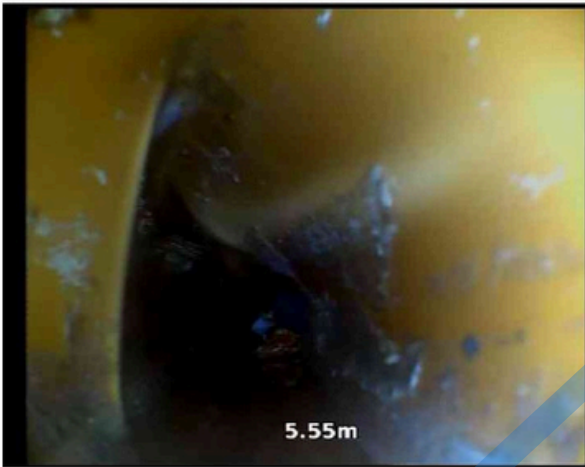
5.55m

MH1X_7896ce19-51e1-4bd7-9fb7-358c01b626eb_20250120_133553_482.jpg, 00:00:30, 5.55 m
 Deformed sewer, 15% of original diameter/height, From 6 to 12 O'clock

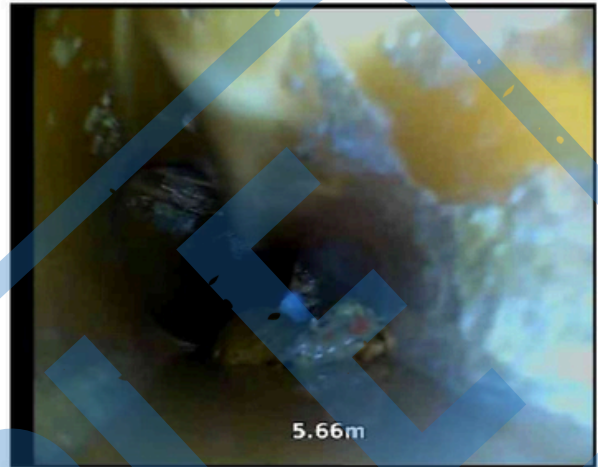
5.66m

MH1X_72b9f780-b977-4ce6-aac6-30e32f2909a7_20250120_133632_377.jpg, 00:00:32, 5.70 m
 Deformed sewer, 15% of original diameter/height, start, 12 O'clock

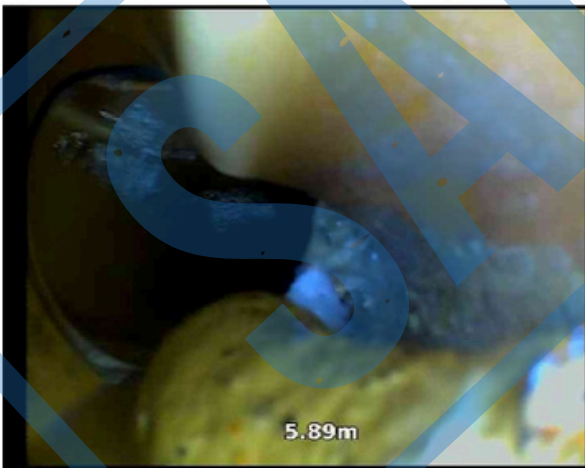
5.89m

MH1X_10093812-9238-453a-99a7-651d7dc8d95c_20250120_133800_238.jpg, 00:00:51, 5.89 m
 Survey abandoned, Unable to push camera

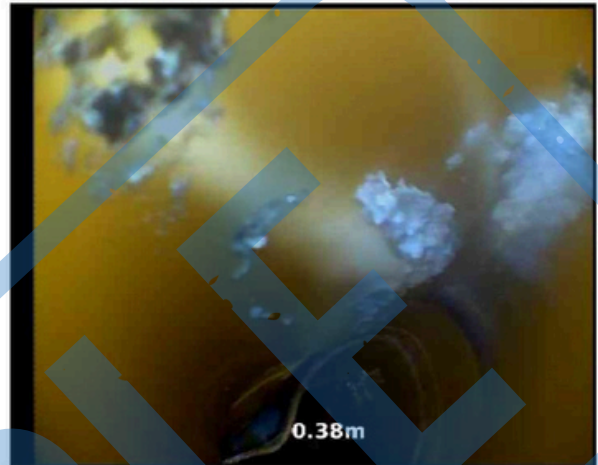
MH1X_2aef634b-99ce-4329-8ae6-b0b68861c6e4_20250120_134027_186.jpg, 00:00:08, 0.38 m
 Deformed sewer, 10% of original diameter/height, start, at 10 O'clock

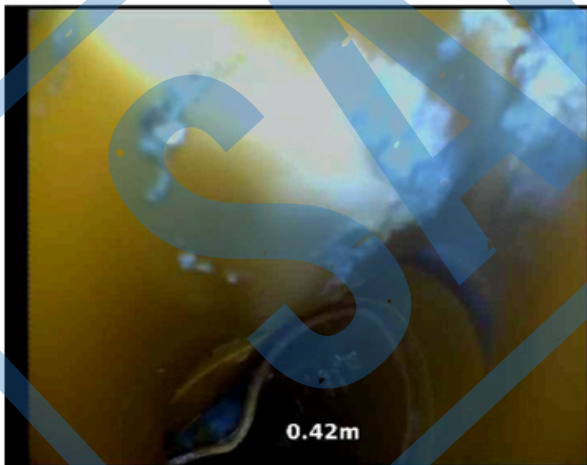
MH1X_31cd0bca-9743-4b55-bd9b-c455b6255c9d_20250120_134102_101.jpg, 00:00:08, 0.42 m
 Deformed sewer, 20% of original diameter/height, change, at 10 O'clock

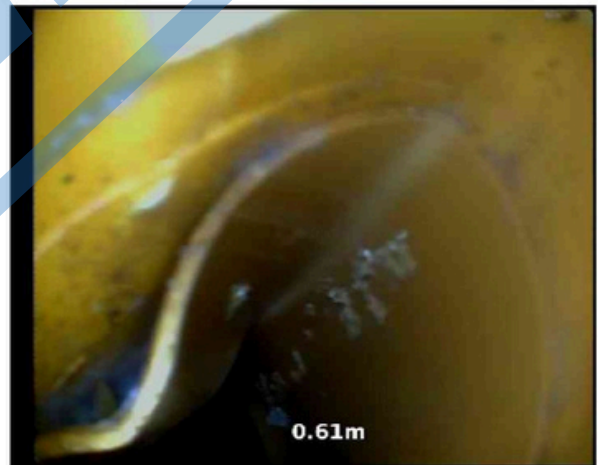
MH1X_0ead1eea-6abd-4097-b27f-b7b020615ea3_20250120_134214_214.jpg, 00:00:09, 0.61 m
 Deformed sewer, 20% of original diameter/height, change, From 8 to 12 O'clock

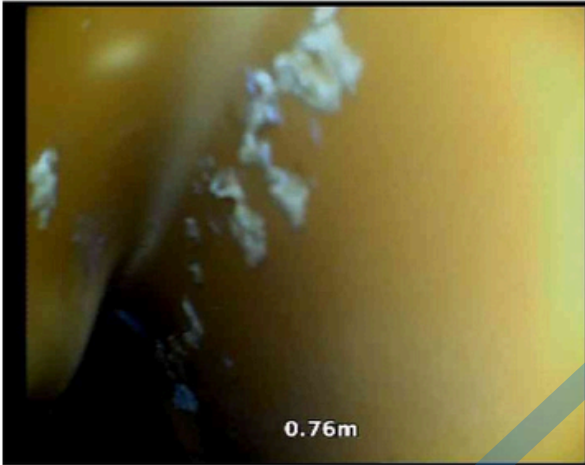
MH1X_a2c45cb7-d2ab-4a43-b42d-48ccef41a087_20250120_134255_553.jpg, 00:00:11, 0.76 m
Survey abandoned, Unable to push camera past
